Avalanche Details

Location: Gunsight Peak, McCormick Creek, Selkirk Mountains

Summary Description: 1 snowmobiler caught, buried, and killed.

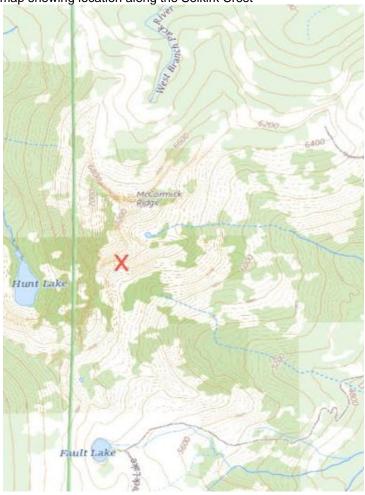
Figure 2- TOPO map showing location along the Selkirk Crest

On Friday, March 9th, at approximately 3:00pm a snowmobiler unintentionally triggered a hard slab avalanche while riding up an open, east-facing, wind-loaded slope. The avalanche started at 6,700' feet just below Gunsight Peak, in the headwaters of McCormick Creek (Fig. 2). Gunsight Peak is a prominent peak in the Selkirk Mountains of North Idaho. The avalanche was a large, hard slab that broke near the storm snow / old snow interface (HS-AMu-R3/D2-I). The avalanche broke approximately 2-3 feet deep, 950' wide and traveled 300-400 vertical feet (Fig. 3).

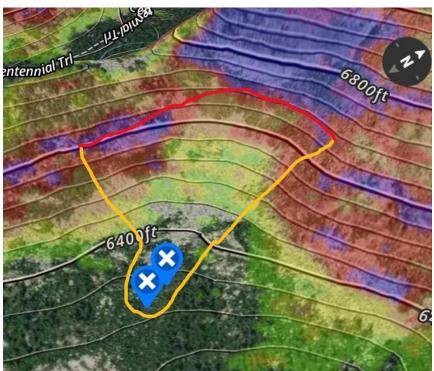
Figure 4- Backcountry OnX map showing slope steepness shading (Red- fracture line, yellow- flanks and toe)

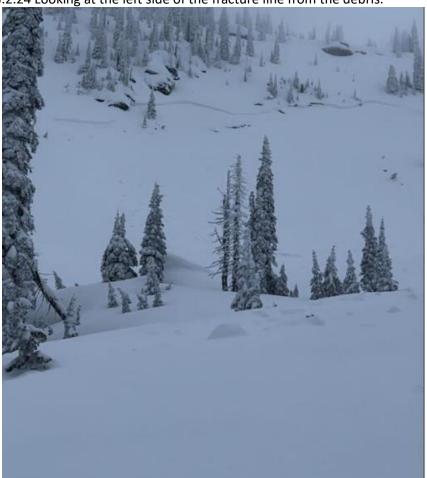
Figure 5-Photo 3.2.24 Looking at the left side of the fracture line from the debris.

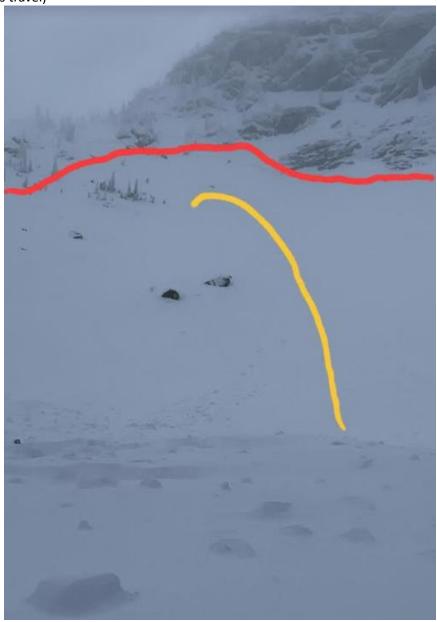
Approximately five minutes after the group split, Snowmobiler 1 ascended a slope above them to high mark, triggering an avalanche while turning at the top (Fig. 6). The 54-year-old rider was caught, separated from his sled, and buried about 4-5 feet deep. He ended up roughly 75 feet from the toe of the avalanche. Prior to heading for the high mark, Snowmobiler 1 instructed Snowmobiler 2 to "Keep eyes on me." Positioned at the bottom of the slope in the runout path he decided to keep his snowmobile running and positioned across the fall line. Snowmobiler 2 witnessed the initiation of the avalanche by Snowmobiler 1, then turned his sled downhill to escape.

The two riders intended to avoid avalanche terrain on this day as they understood conditions to be unusually dangerous. That final high mark started on a shallow slope that gets progressively steeper. The point of trigger was approximately 37-40 degrees in steepness, which is the sweet spot for avalanche starting zones.

Figure 6- Photo 3.2.24 Looking uphill at the fracture line (Red- fracture line, yellow- approximate path of snowmobiler 1's travel)
