Avalanche Details

Location: Gunsight Peak, McCormick Creek, Selkirk Mountains

Summary Description: 1 snowmobiler caught, buried, and killed.

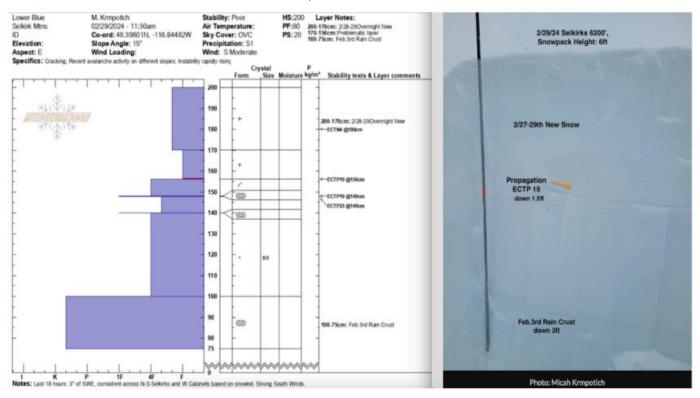
Figure 1- Data pit, 2.29.24, Approximately 8 miles from the accident site on the same ridgeline IPAC Avalanche Technician- Micah Krmpotch
